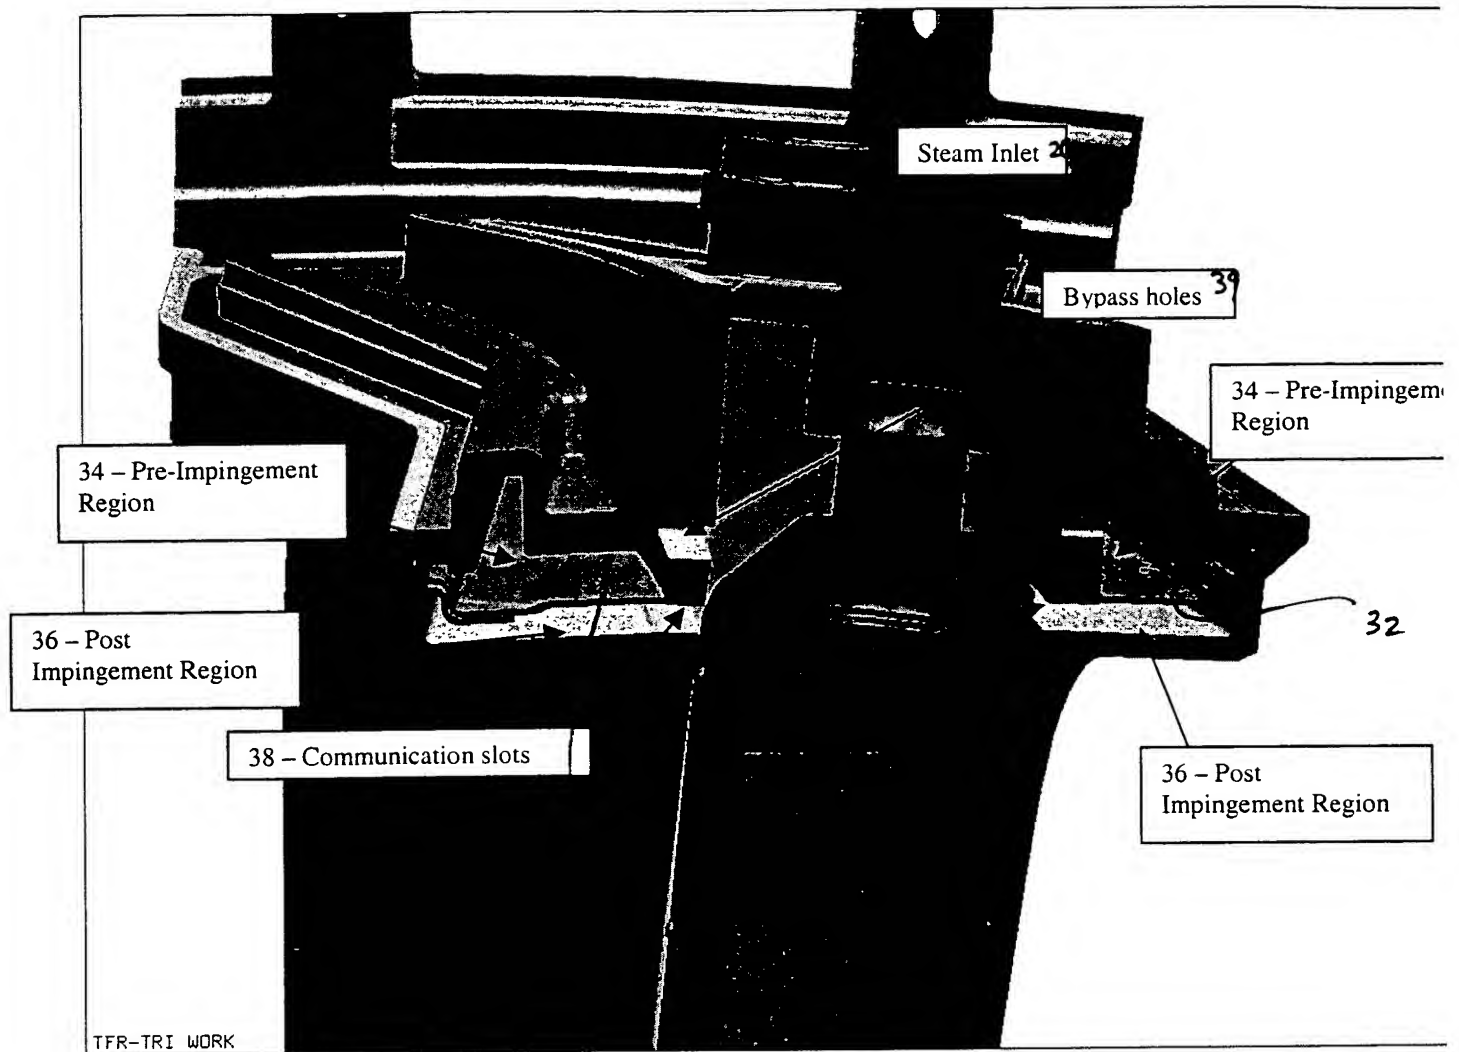
FIG. 2

Communication slots/bypass holes on the outer sidewall/band. (Shown with impingement plates and other hardware)
